Installation of Main Firmware

Installation of Bar Code Firmware Options

Installation of Coax and Twinax Firmware Options

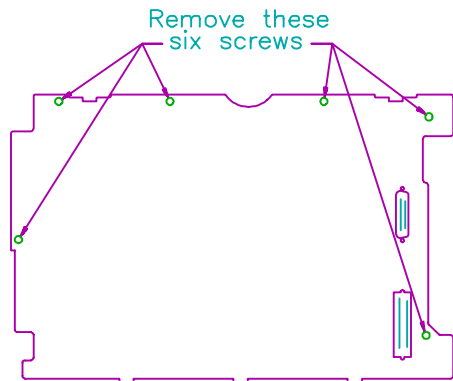
1. Turn printer power off and unplug from power source.
2. Remove the six screws that attach the rear panel on the back of the printer.

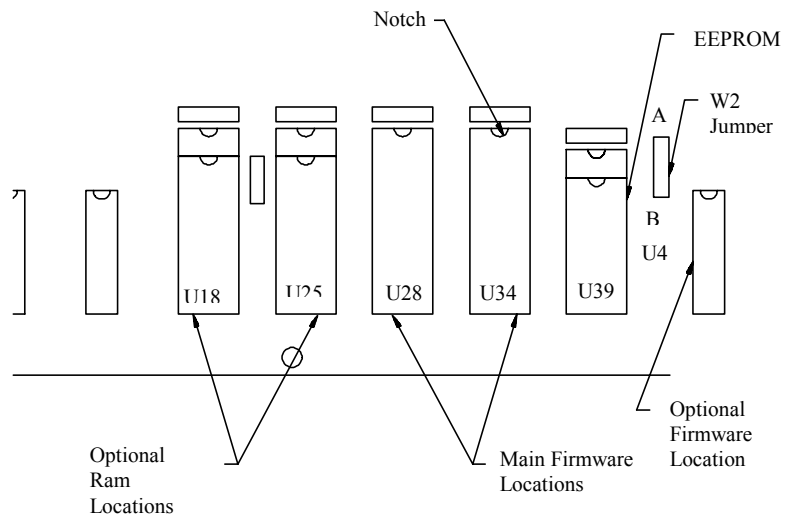
4. Remove the proms from locations U28 and U34.
5. Install the replacement proms in locations U28 and U34.

Be sure that the notch in the prom matches the notch in the silkscreen on the board. Failure to do so may result in damage to the prom or the board.

FOR OPTIONAL RAM: PLACE CHIPS IN THE LOCATIONS SHOWN ON RIGHT (U25 AND U18).

To utilize the expanded ram, change Buffer Size feature value (under M4 Printer Control).
 For Optional 8K EEPROM: Place 8K EEPROM into location A shown (U39)
 Move jumper on W2 to the “B” position.

1. Perform the Steps 1 through 3 of Installation of Main Firmware on page one (1).
2. Install the two (2) ram chips in locations U25 and U18, if required.
